# METRO THERMAL ASH MONOFILL CLOSURE CAP

## STORMWATER DAMAGE AND RESTORATION UPDATE

# METRO THERMAL ASH MONOFILL

## Metro Nashville Public Works

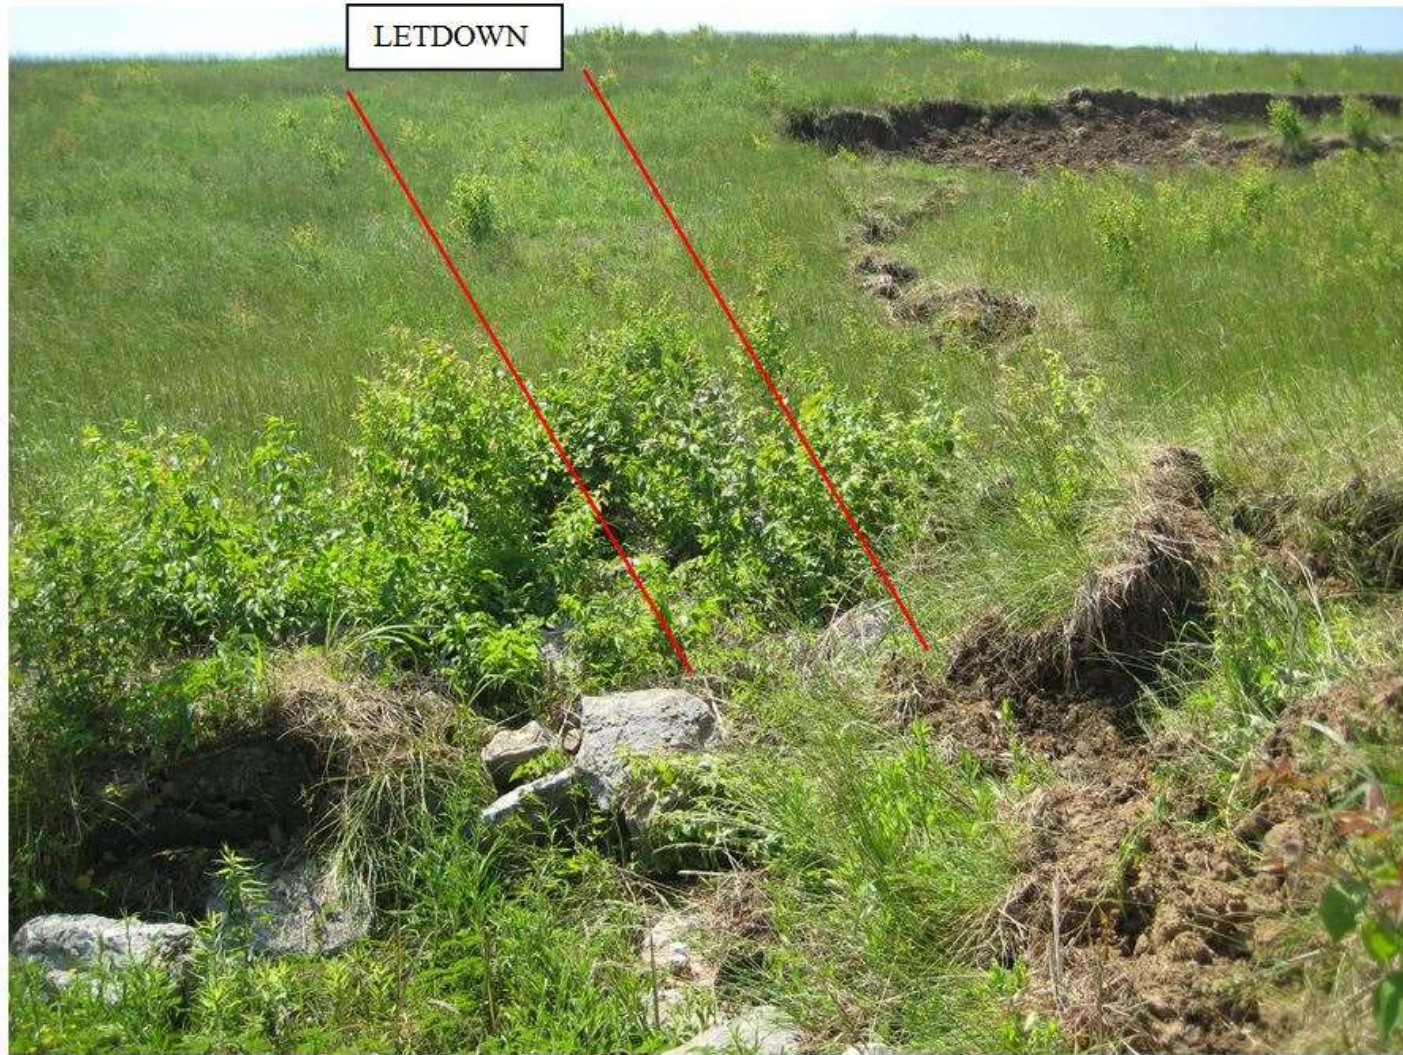
**Photo 4.** (North Slope) Crack and Letdown at East Side of Failure, Scarp at Top

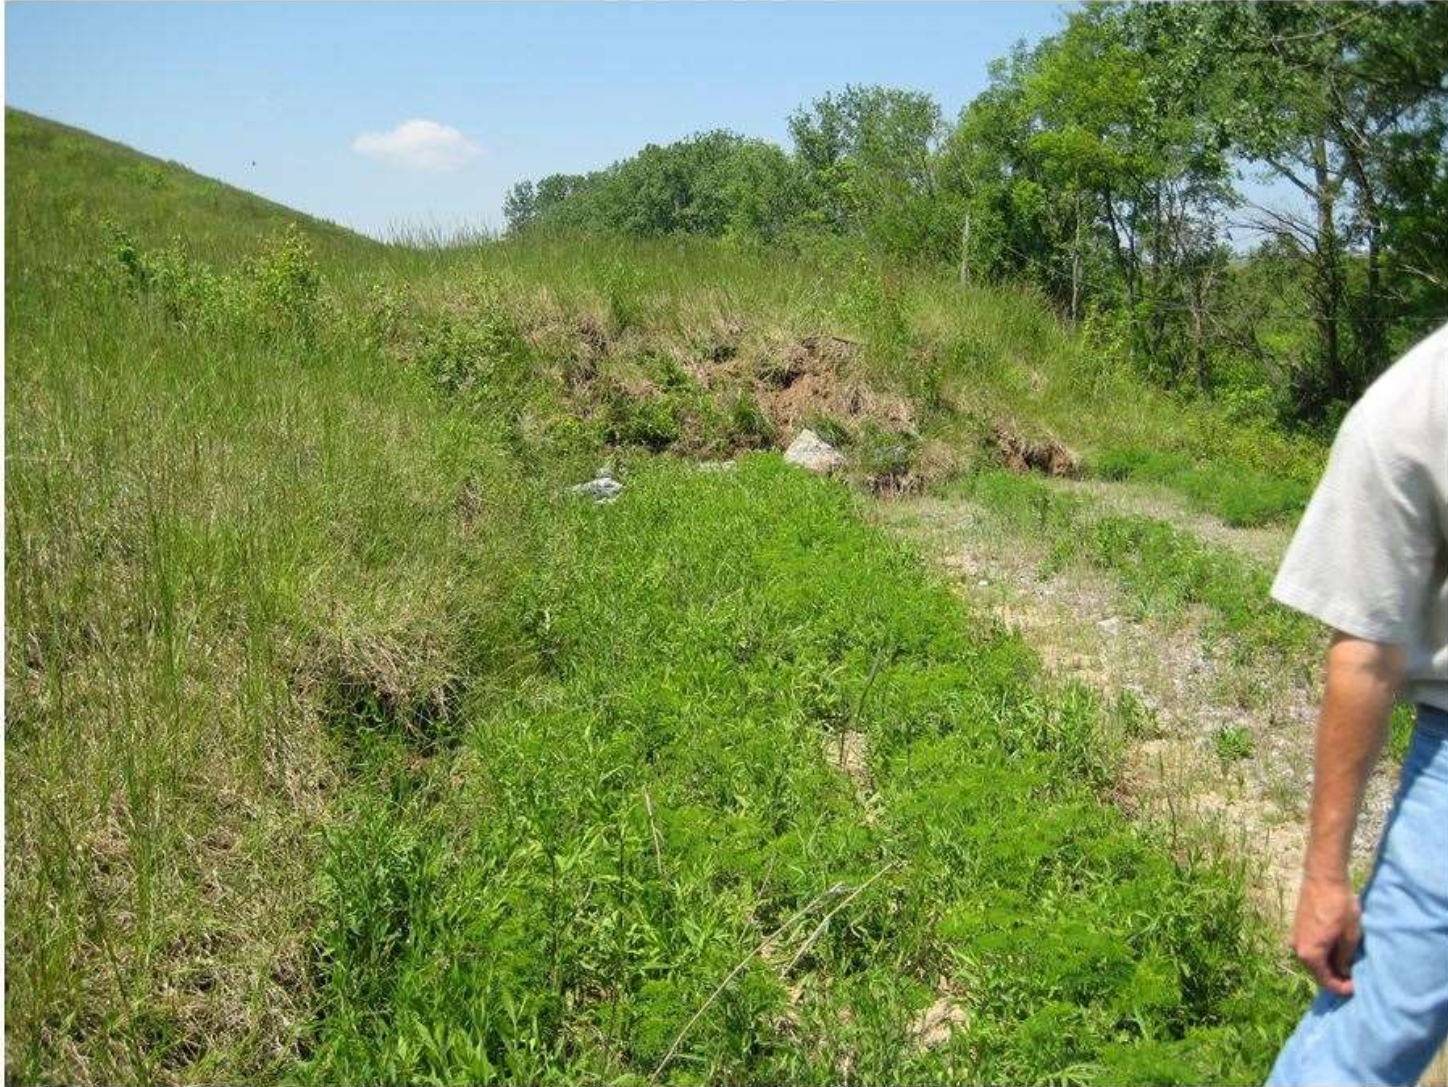
**Photo 5.** (North Slope) Sloughed Cover Soil at Toe

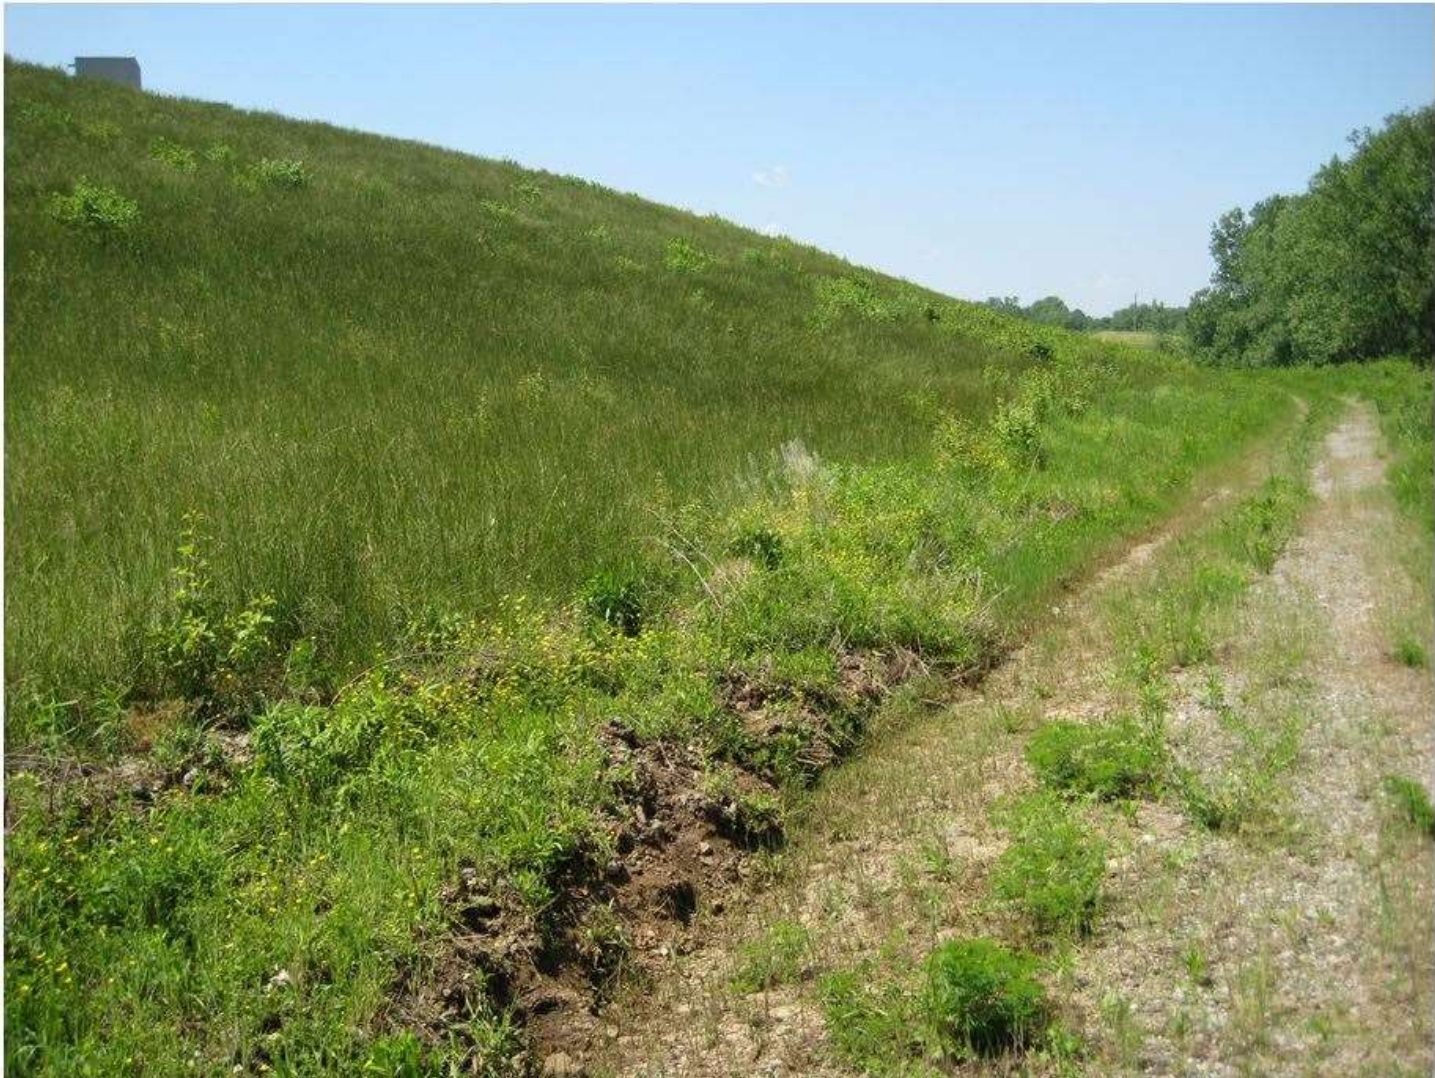
**Photo 6. (North Slope) Bulge at Toe**

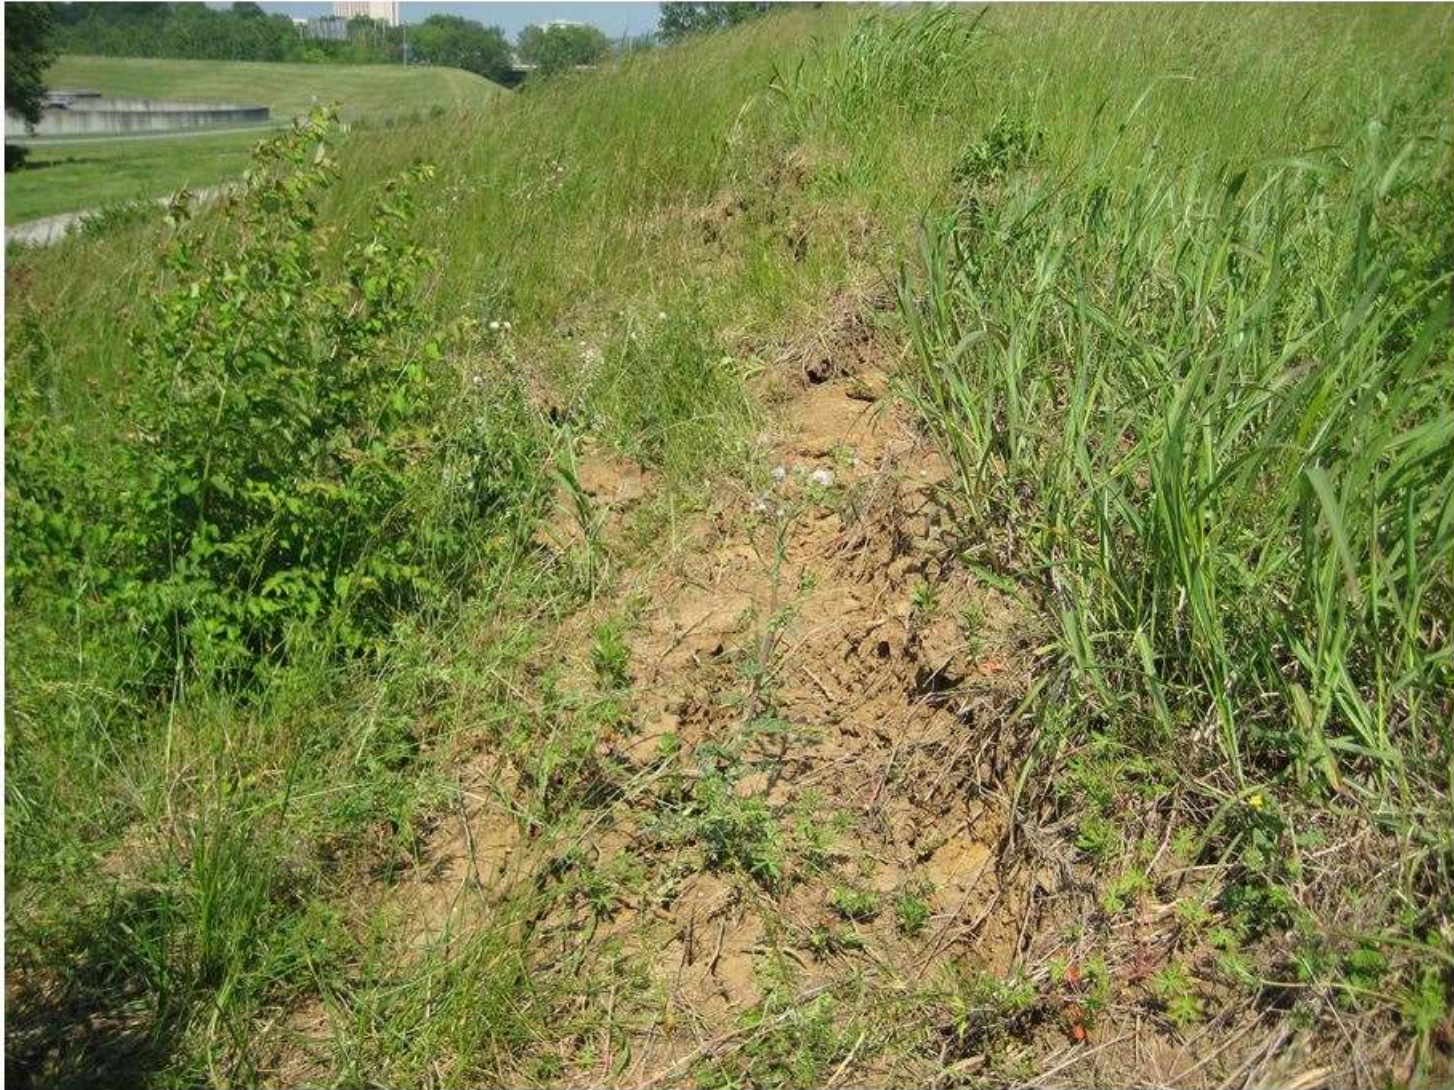
**Photo 8. (South Slope) Bulge at Toe**

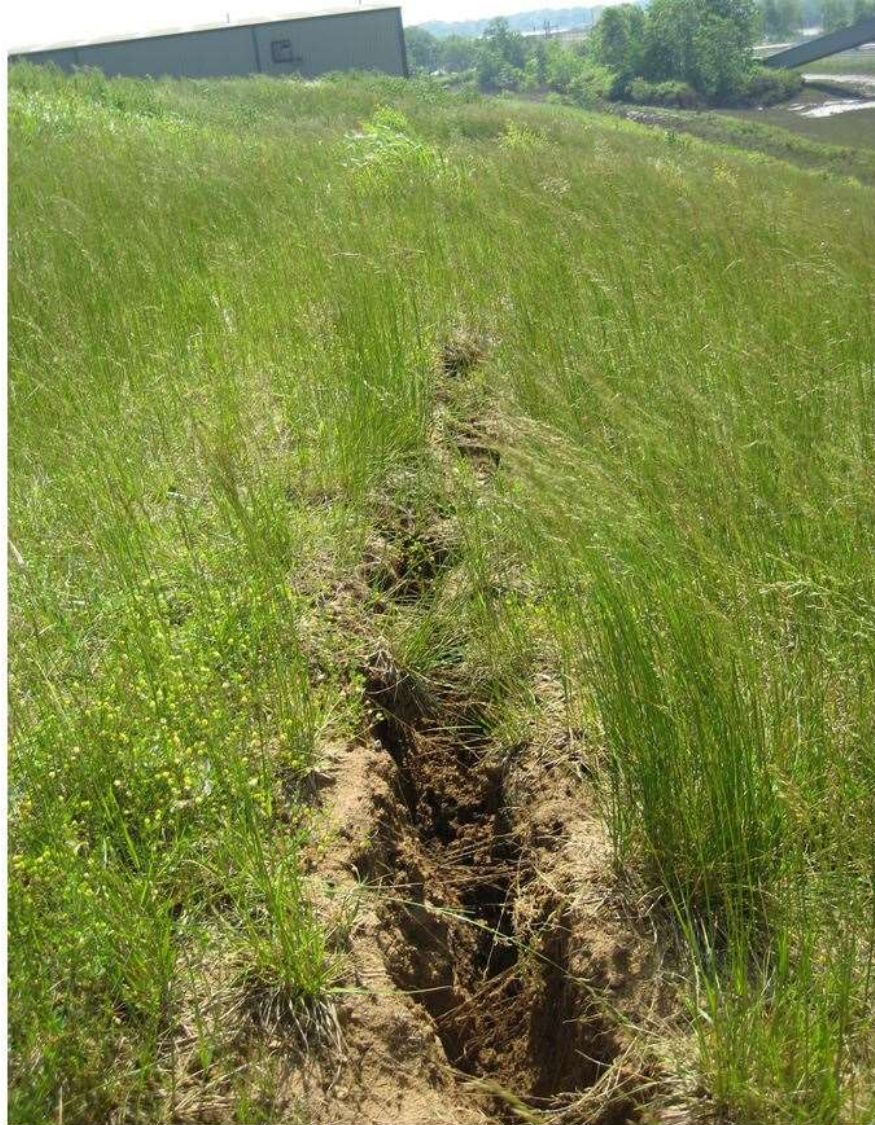
**Photo 9.** (South Slope) Tension Crack Below Bench

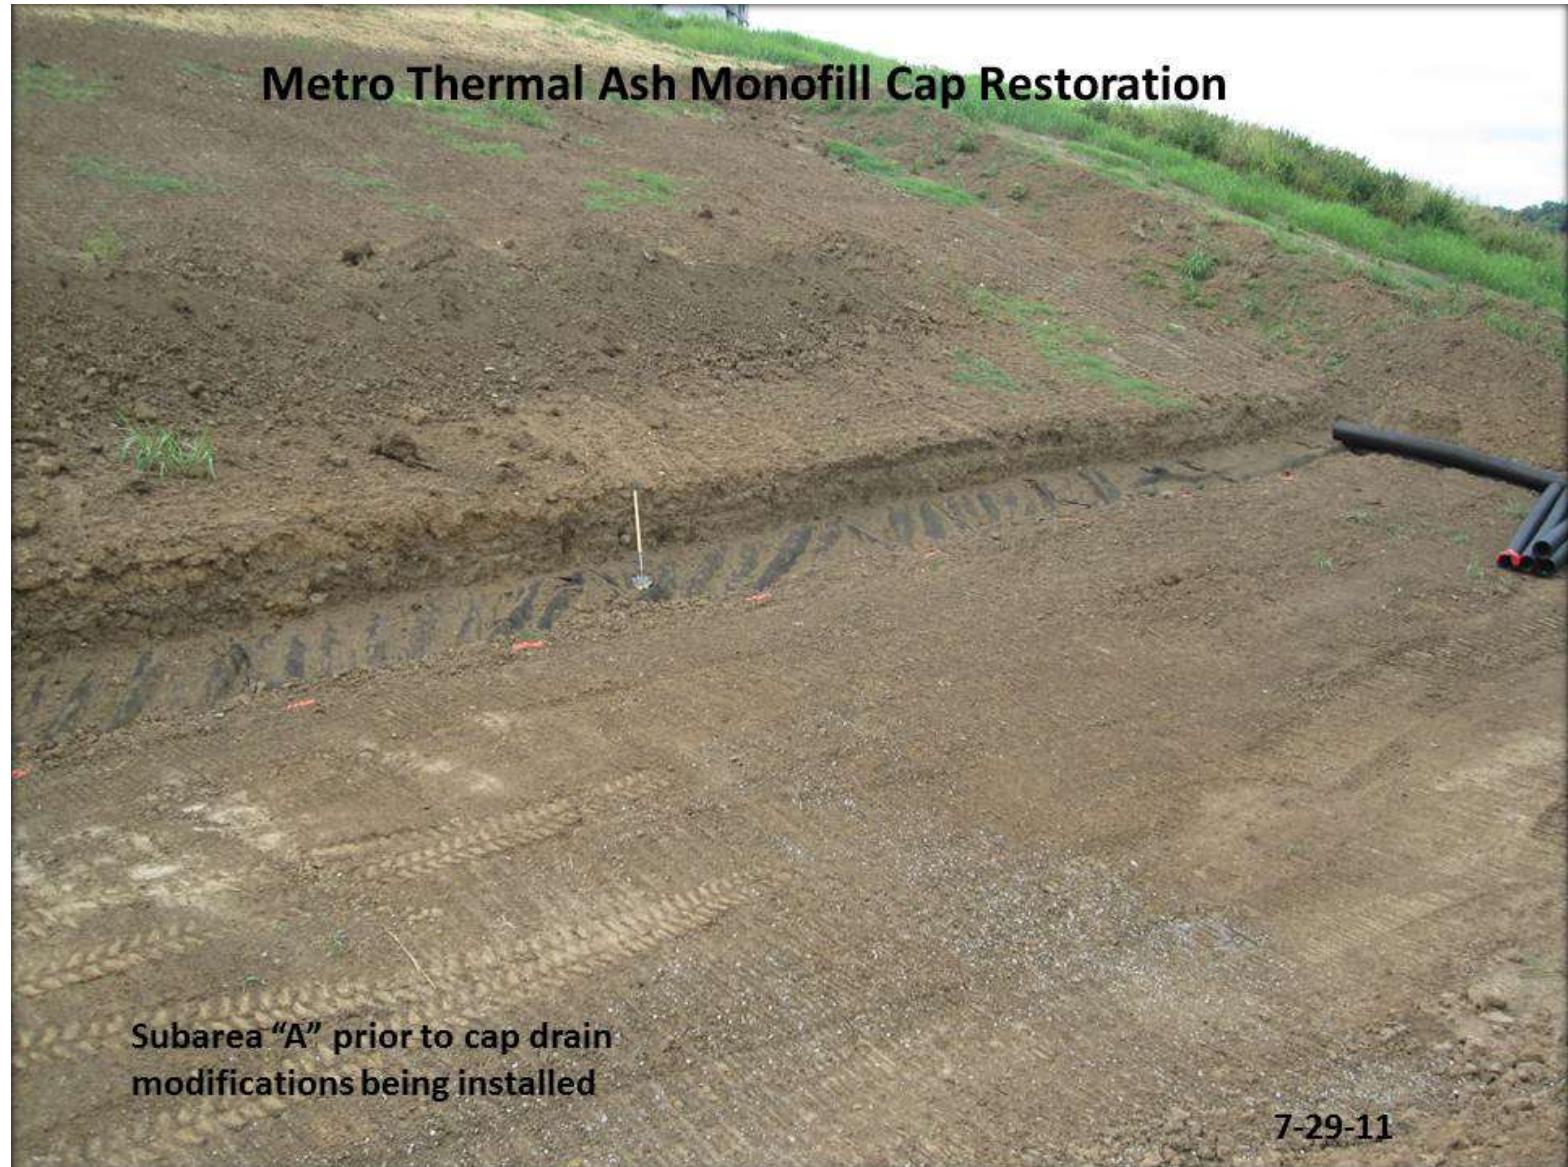
**Subarea "A" prior to cap drain  
modifications being installed**

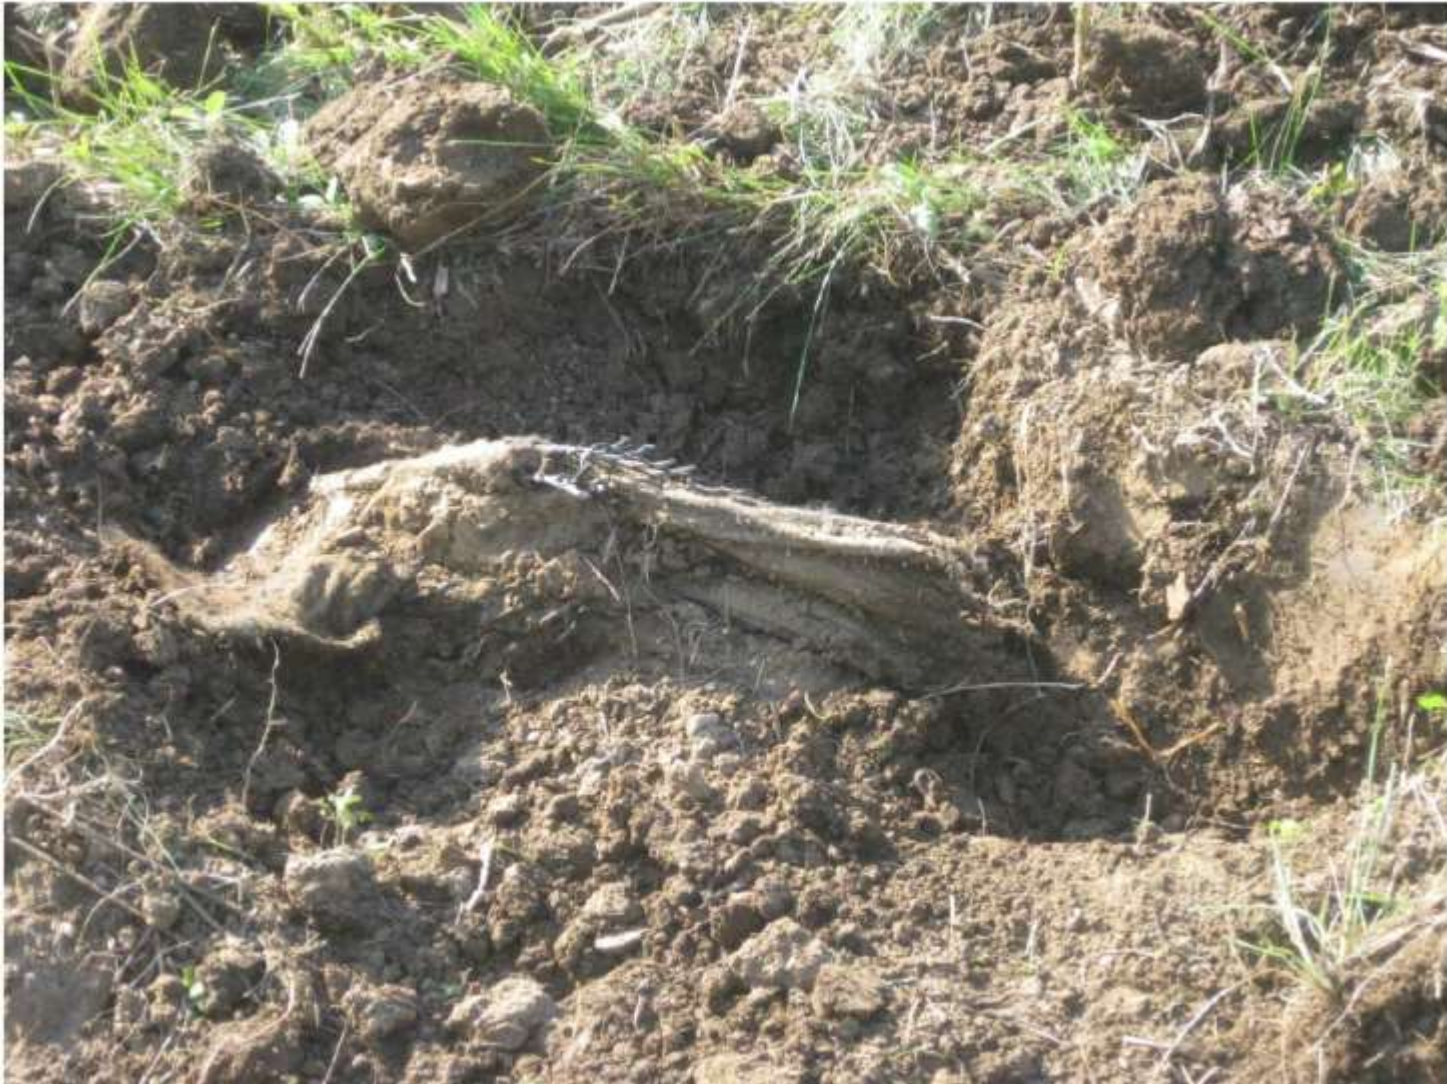
**Subarea-D, exposed composite in toe of slope soil bulge, close up**

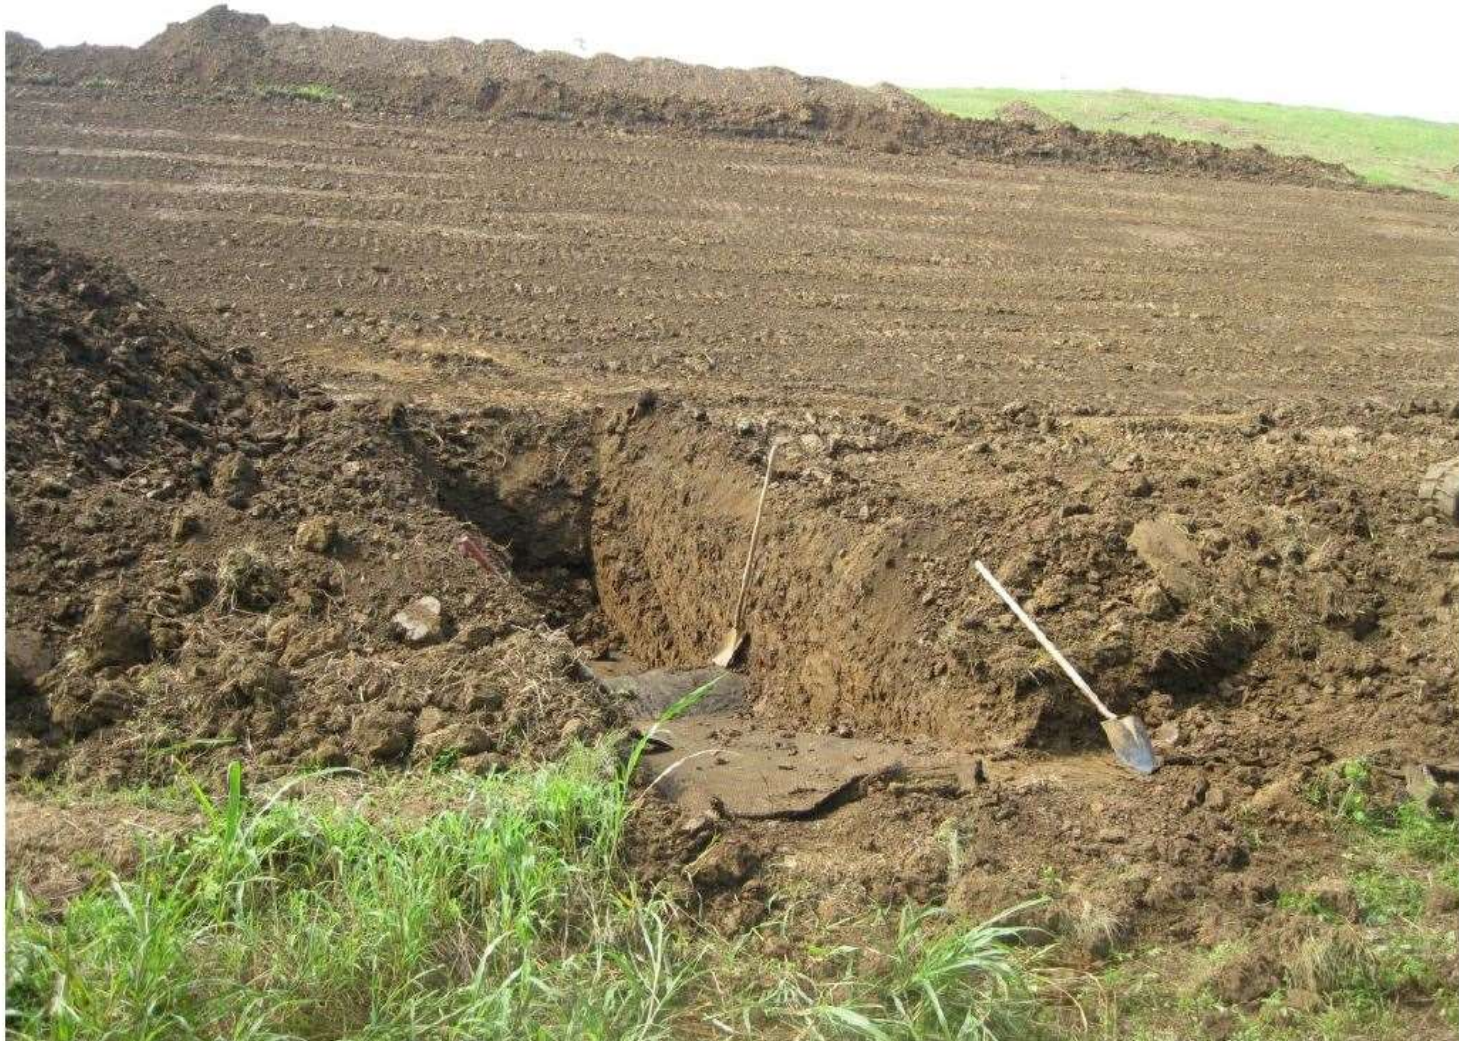
**Subarea-D, locating underdrain, edge of drainage composite exposed**

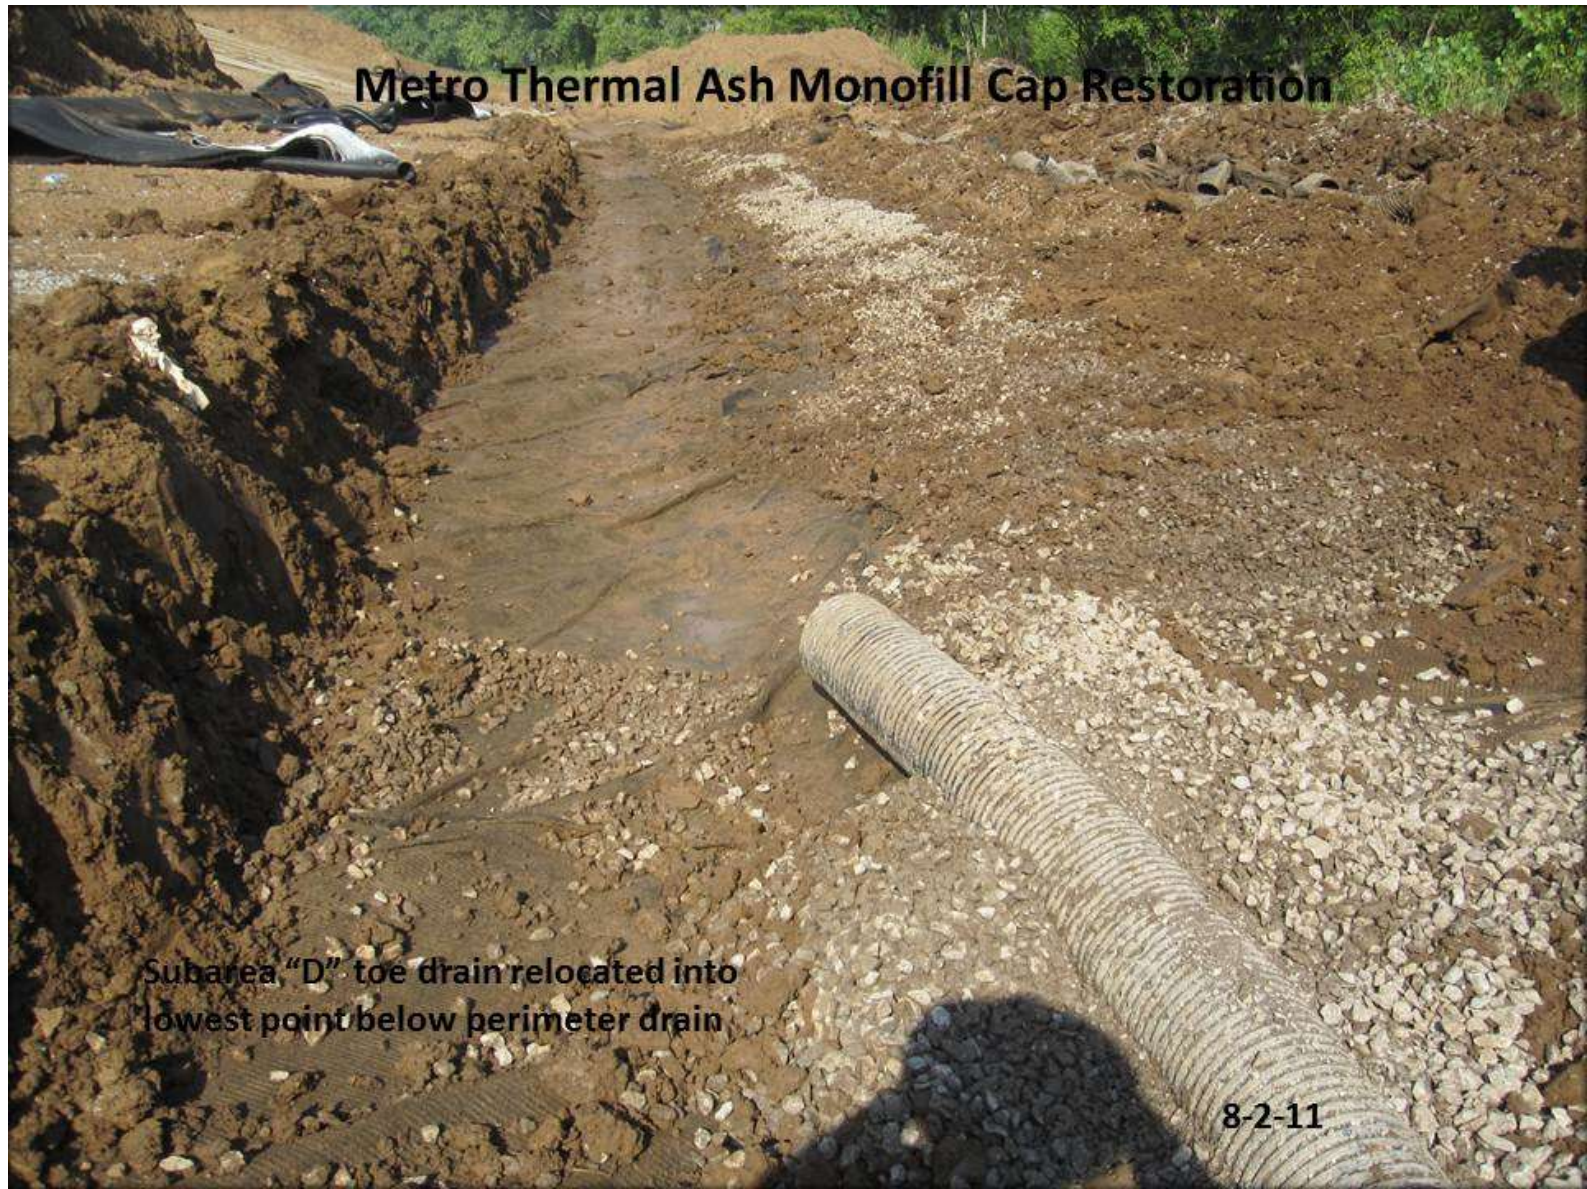
- ❖ Perimeter Toe Drain in SubArea C/D was crushed (~ 120 LF)
- ❖ Perimeter Toe Drain in SubArea D was mis-located (i.e. not in the low point) and not perforated.

Subarea "D" toe drain relocated into  
lowest point below perimeter drain

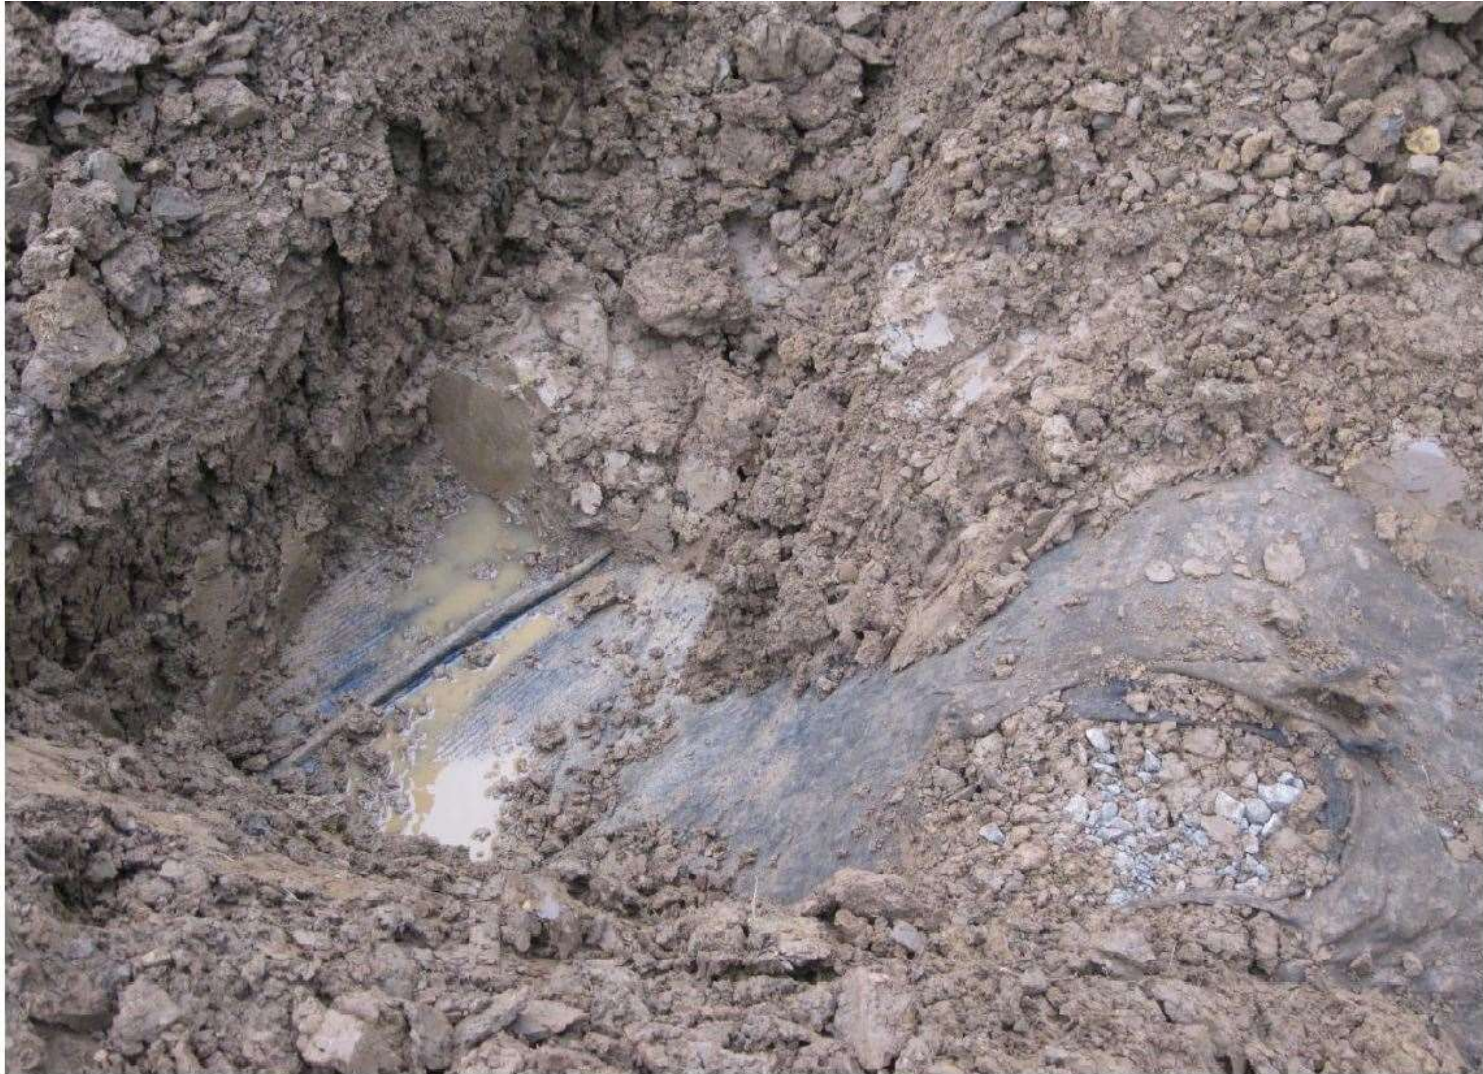
Subarea-D, locating underdrain pipe, pipe out of subgrade ditch, standing water where pipe should be in ditch

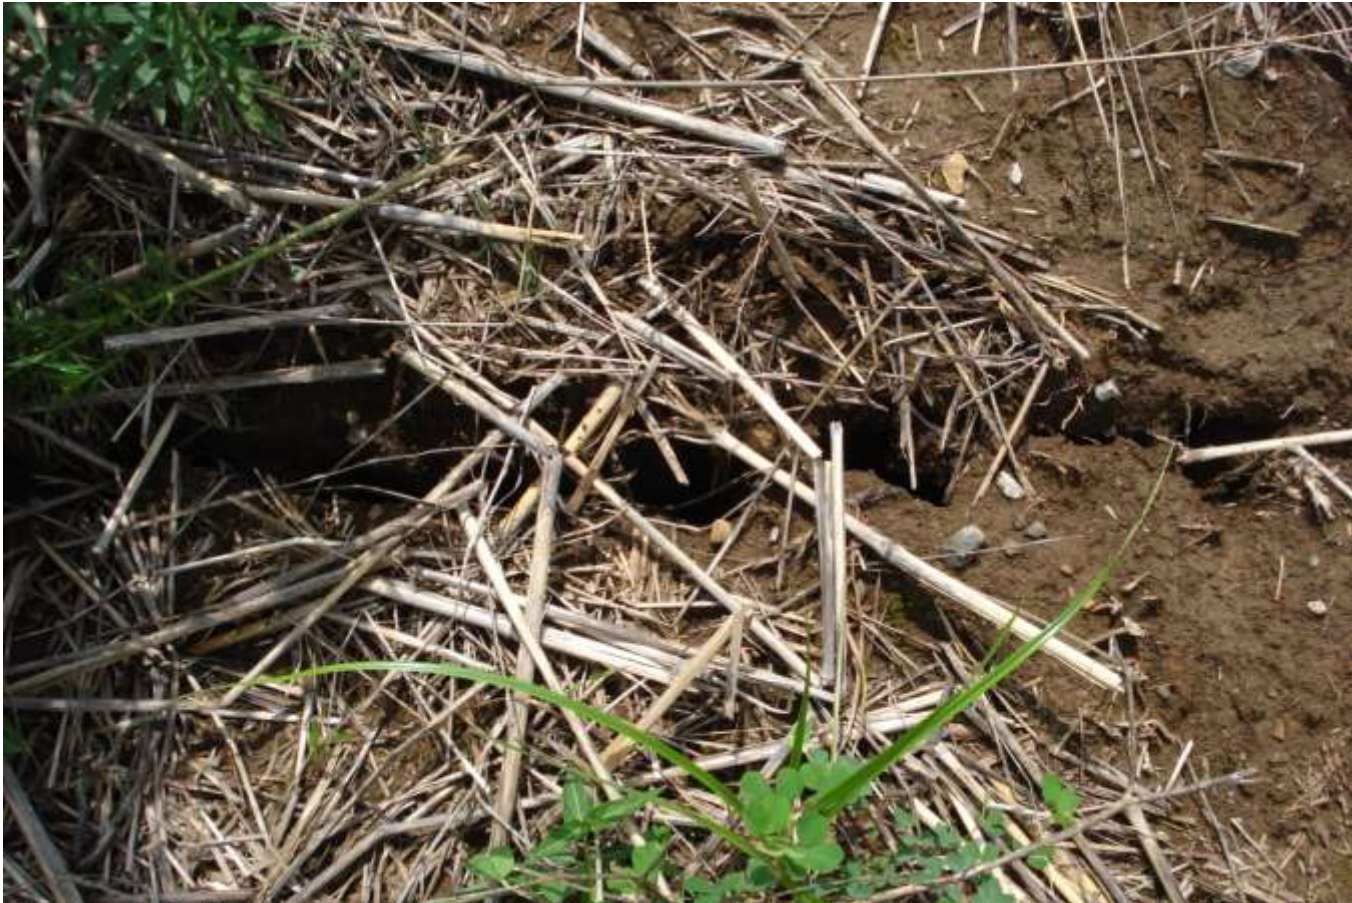
## **South Slope Cracks – July 2012**

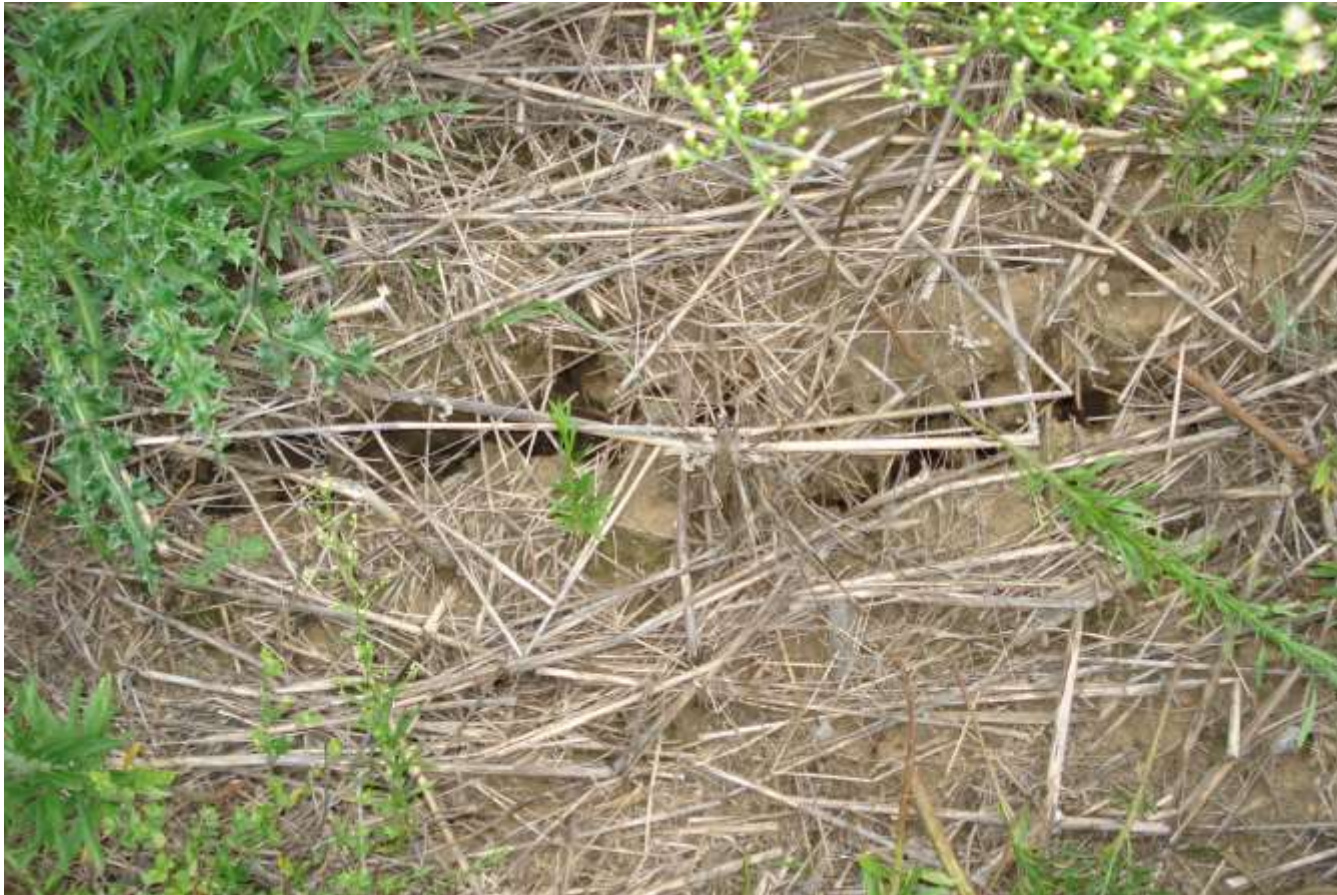
## **South Slope Cracks – August 2012**

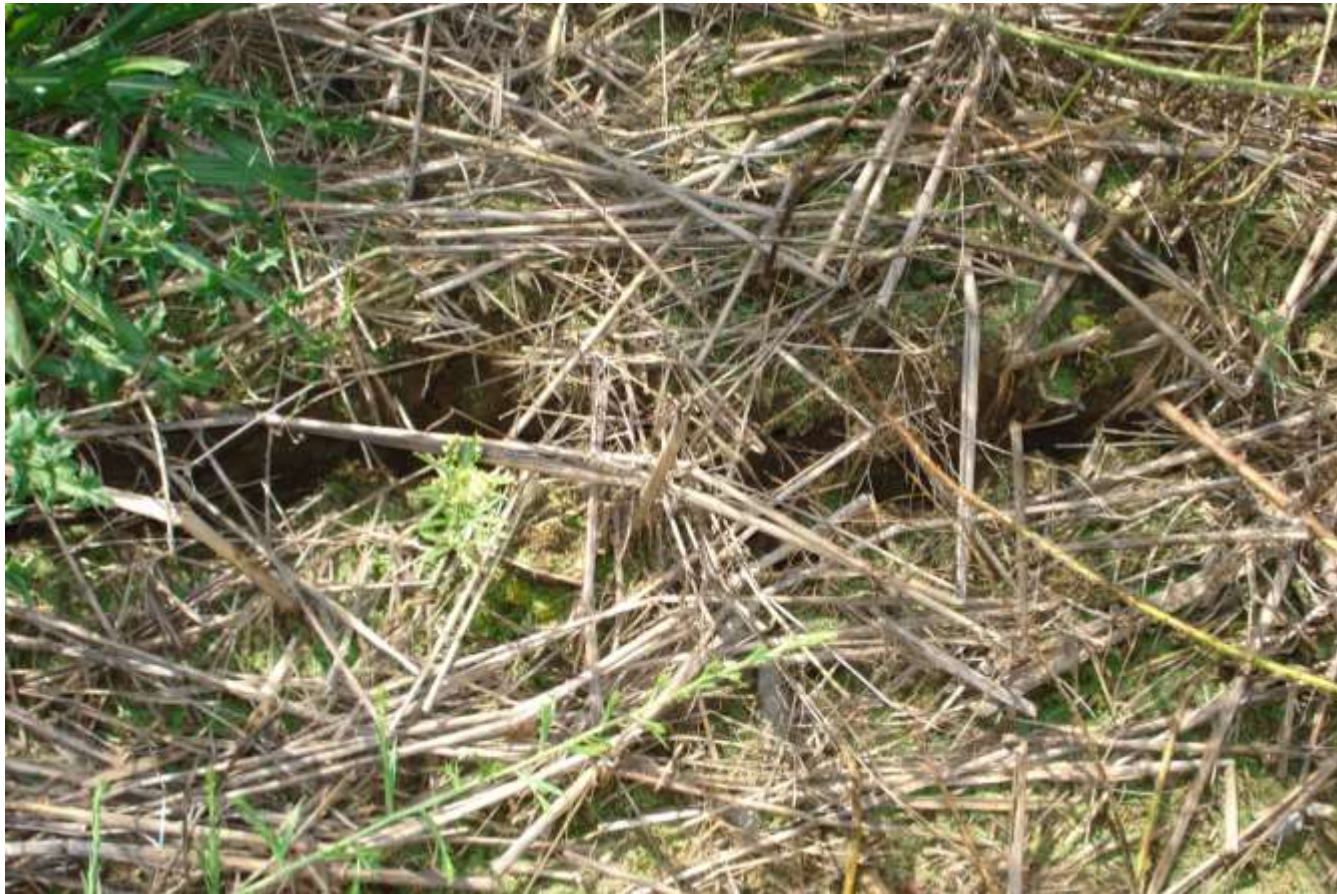
## **South Slope Cracks – September 2012**
